## **FORGOT THE MAGDYNO STRAP?**

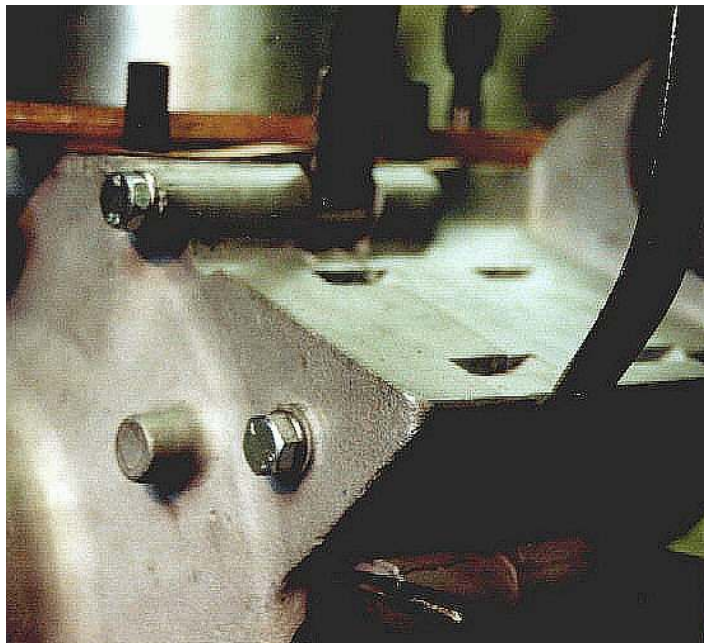
These straps are fixed with two studs: crankcase stud (top, rear) 31-212 and crankcase stud (rear) 24-949. And if you forget to slide on those straps before assembling the two crankcase halves, you have a problem, because it is virtually impossible to get those studs out again once the crankcase halves are together. The protruding thread is too short to screw on a second nut, so you can either fix the nut on the stud with a punch and several hammer blows, or weld the nut on the stud, or separate both crank case halves again.

A better solution? Replace beforehand both studs with bolts; take long enough M8 bolts, cut off the threaded part and put 5/16" Whitworth thread on them (as said, you could weld the nuts on the studs, but I think that's a botch). Now you can replace those Magdyno straps without separating the case halves.
